Manhole Inspection Summary

Manhole # S69S__018MH

Insp Date: **4/22/08 9:51 AM**

Location Address: **1600 Dundalk Ave.**

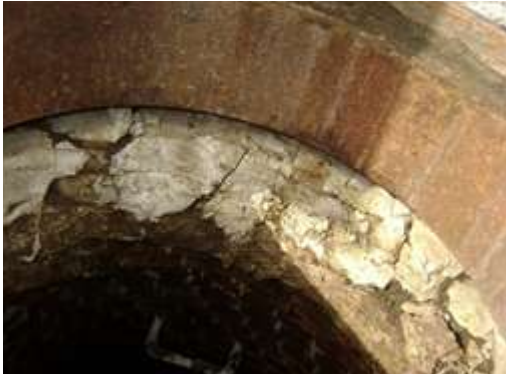
Defect 1

Condition: ☐ Sound ☐ Cracked ☐ Root Intrusion ☒ **Loose Brick** ☒ **Deteriorated**

deterioration

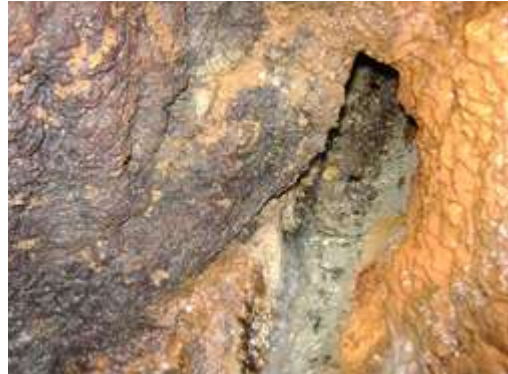
Defect 3

Comments **HEAVY DEPOSITS ATTACHED ENCRUSTATION ON INCOMING 3 O'CLOCK**

deposits attached encrusted on incoming
3 o'clock line

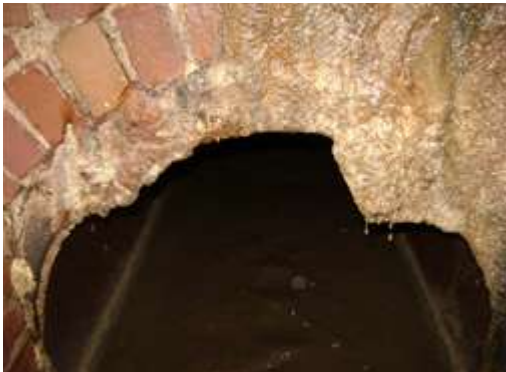
Defect 4

deposits attached encrustation on barrel
wall above outgoing 12 o'clock

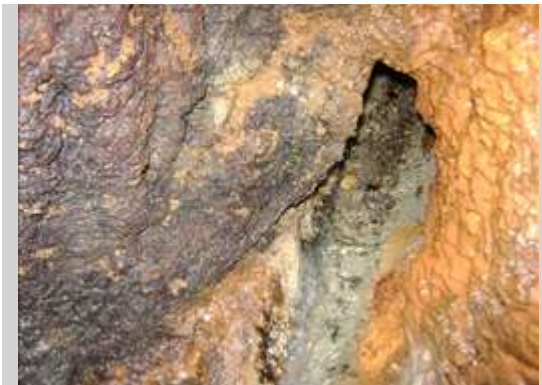
3 O'Clock Inflow

Heavy deposits attached encrustation

Pipe Height: **8.4** (in.) Rod and Bar (Angled)
Pipe Material: **Clay** ☐ Pipe Lined
Invert Depth: **9.96** (ft.) Flow Characteristics: **Slow**
Deposits: ☐ None ☐ Mud ☐ Sludge ☐ Debris ☒ Grease
Silt Depth: **0.125** (in.) Deposits Extent: **Light**
Infiltration: **None** Pipe Seal Cond: **Sound**
